HYDRAULIC MODEL STUDIES OF THE
BARTLETT DAM SPILLWAY
SALT RIVER PROJECT, ARIZONA

Report No. Hyd-576

October 2, 1967

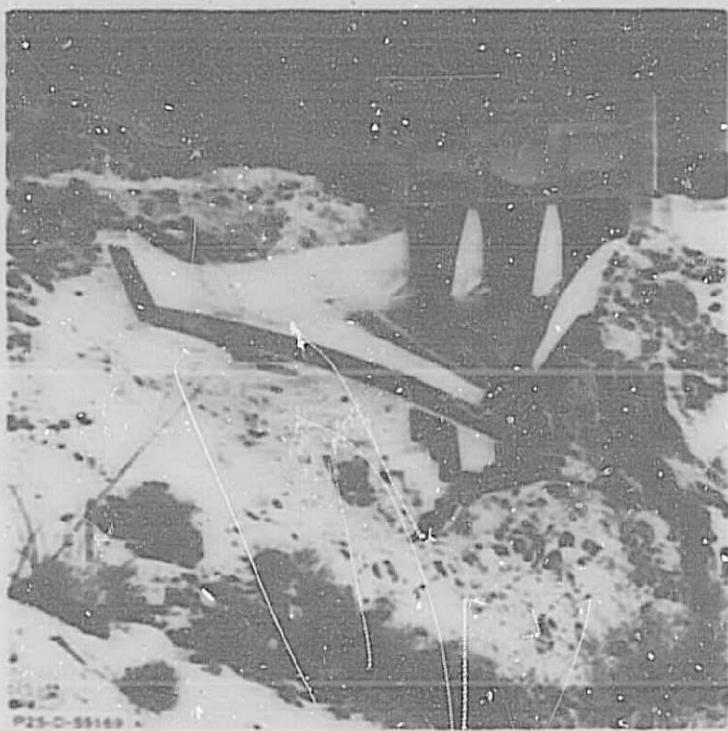
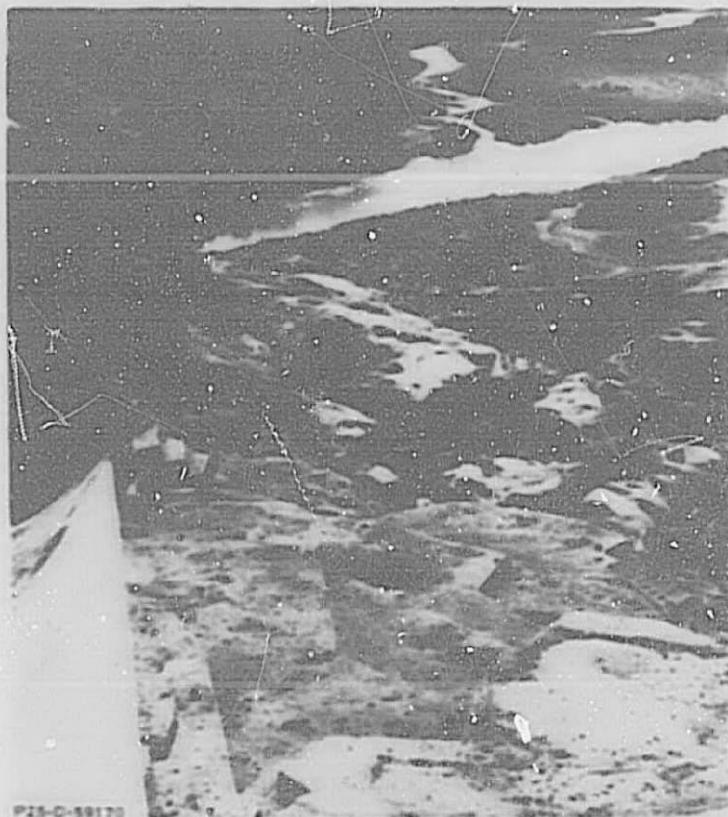
Figure 2
Report No. Hyd-576

Floods in 1942 and 1965-66 severely eroded the excavated channel. Prior to the 1965-66 flood, the channel was repaired by placing mass concrete in retaining walls and blocks in the badly eroded portion of the channel near the downstream end of the chute (Figure 2). The 1965-66 spillway flows, estimated at 28,500 cfs (806.55 cms) from near-maximum reservoir elevation, washed out or undermined these concrete slabs and blocks in several areas (Figure 3). Erosion of the rock was quite rapid where the concrete had overlain the weak, weathered granite. At the base of the steep portion of the eroded channel, about 100 feet (30.48 meters) downstream from the concrete chute, one hole was eroded in the weathered rock to a depth of about 15 feet (4.57 meters).

BARTLETT DAM SPILLWAY
DISCHARGE CHANNEL EROSION AND REPAIRS
PRIOR TO THE 1965-66 FLOOD

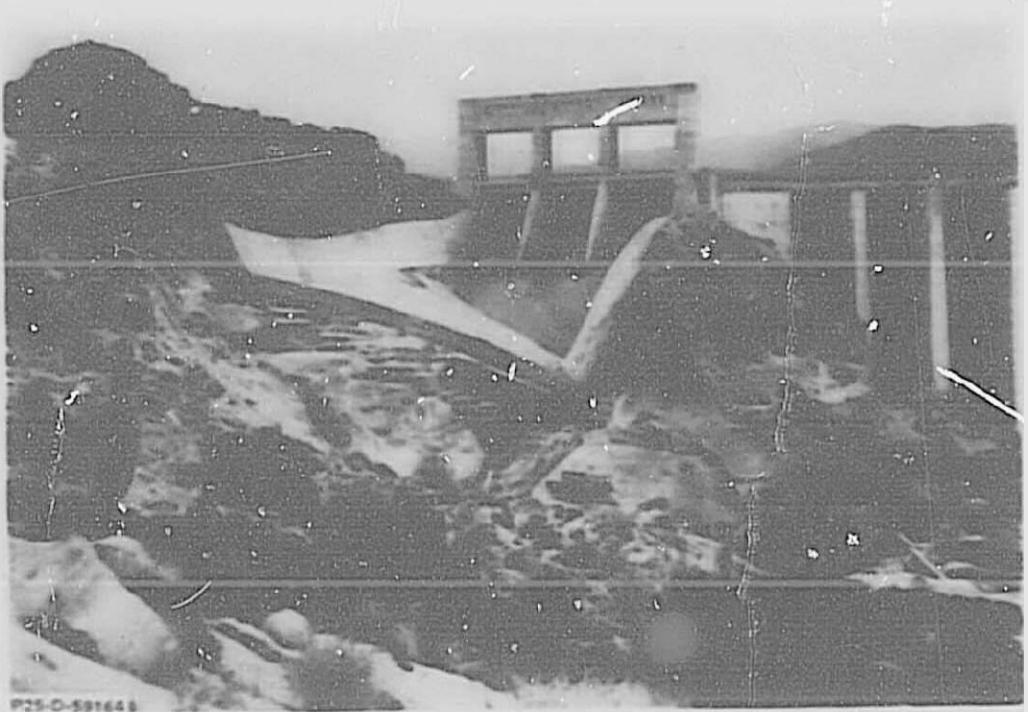
Figure 4
Report No. Hyd-576

Even with all three gates equally opened, portions of the flow impinged on the left and right sides of the discharge channel beyond the limits of the paved area. These areas of impingement are subject to erosion during future spillway discharges (Figures 4, 5, and 8). Erosion on the right side will occur far enough downstream that it is not likely to endanger the structure or undermine the paved area (Figure 5). Erosion may occur adjacent to the left concrete wall of the spillway chute and farther downstream along the left bank (Figure 4). The paving should be extended to prevent this erosion (Figures 9 and 11).

Spillway discharges have eroded a 15-foot (4.57-meter)-deep hole at the base of the steep slope in the prototype discharge channel.

(Figure 4). Further spillway operation possibly will increase the size of this hole and undermine the concrete paving on the steep slope. This hole should be filled with concrete extending from the existing concrete on the upstream side to the rock on the downstream side of the pool (Figures 7 and 11). Sloping this concrete fill downward from approximately elevation 1635 to elevation 1616 in the direction of flow along the existing channel (Figure 7) will flush loose rock downstream during spillway operation.

Water stands in a 15-foot (4.57-meter)-deep hole eroded at the base of the steep slope. Areas subject to future erosion are indicated by the arrows.

3. The deep erosion hole at the base of the steep slope should be filled with concrete (Figures 4, 7, and 11). This concrete fill should extend from the existing concrete on the upstream side of the hole to sound rock on the downstream side and should slope downward to the left in the direction of flow to flush loose rock from the channel.

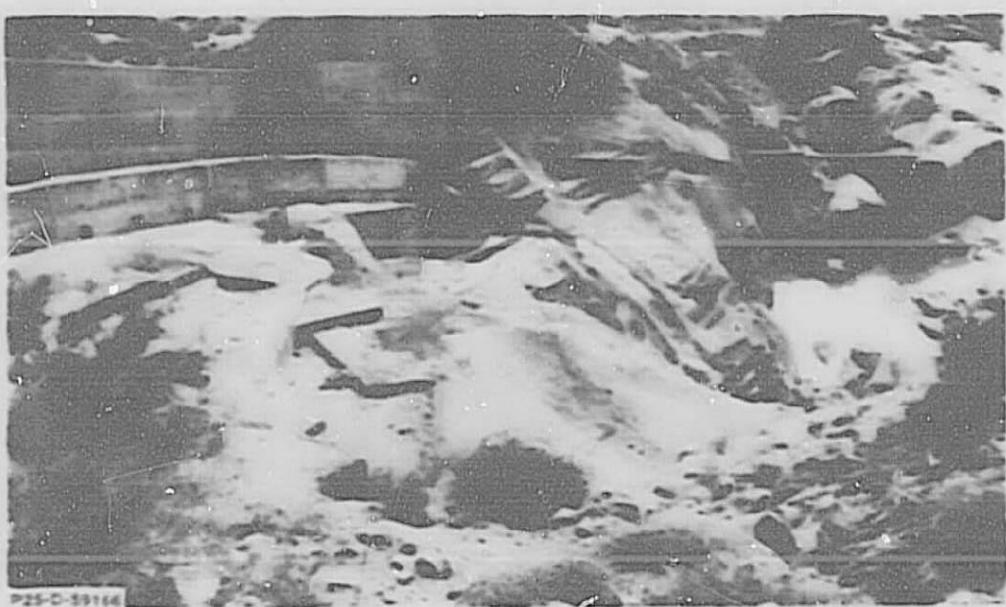
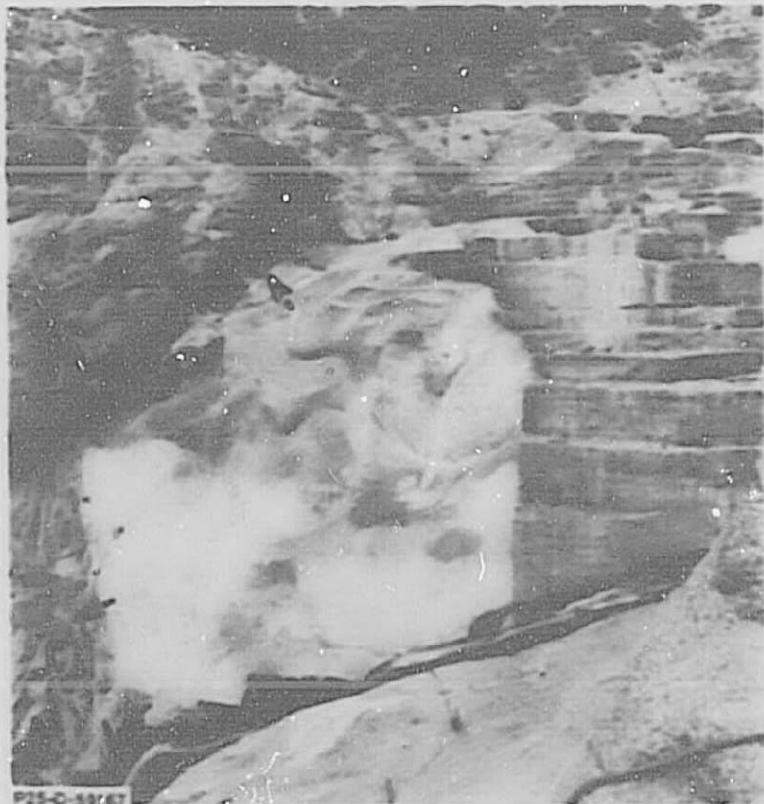
Figure 5
Report No. Hyd-576

Remedial work in the channel after the 1965-66 flood consisted of repairing damaged concrete blocks and protecting rock surfaces with formed or pneumatically placed concrete anchored to the rock (Figures 4 and 5). The hydraulic model studies described in this report were performed to determine channel improvement or additional protection necessary to prevent further erosion near the spillway chute and to determine the combination of operating gates that will provide the best flow distribution.

Areas subject to future erosion are indicated by
the arrows.

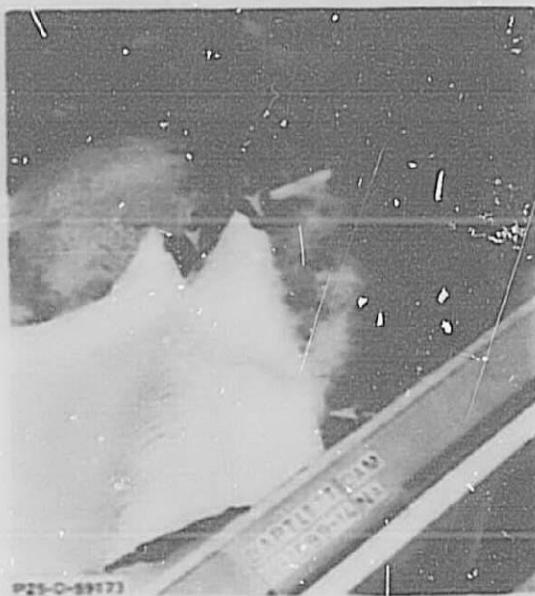
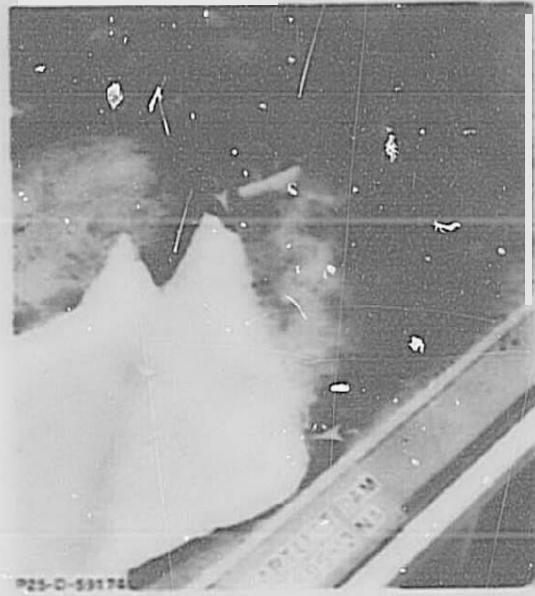
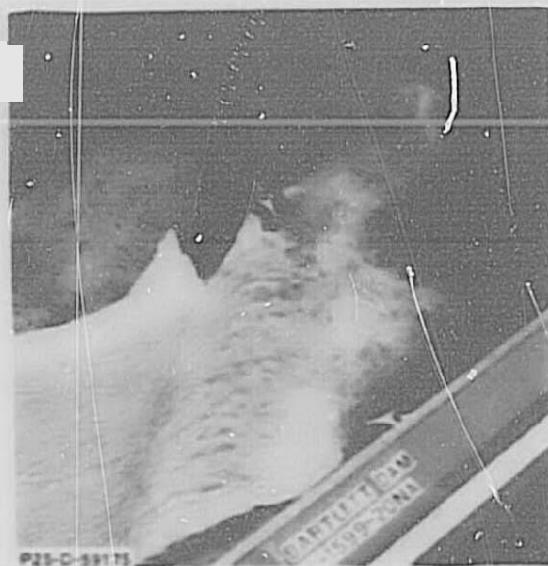
Figure 8
Report No. Hyd-576

The model was operated at discharges up to 50,000 cfs (1,415 cms) to determine flow conditions that might have caused the erosion. At discharges of 10,000, 20,000, and 50,000 cfs (283, 566, and 1,415 cms) flow from the spillway impinged on the areas that had been badly damaged in the prototype channel (Figure 8). The severest damage appeared to have occurred where the impact forces of the jet had apparently loosened and eroded the rock at the weathered joints. Initial tests made with the erodible channel indicated that the erosion began at the left downstream corner of the concrete-lined chute and progressed downstream as the discharge increased (Figure 9). This test confirmed the belief that the major portion of the erosion was due to flow impact rather than to rocks churning in the turbulent flow.

The areas of flow impingement on the left and right banks beyond the white paved area are indicated by the arrows.

5. The spillway gates should be equally opened for best flow distribution at the flip bucket (Figure 8).
6. The two ridges partially blocking the downstream end of the channel should not be removed (Figure 13).

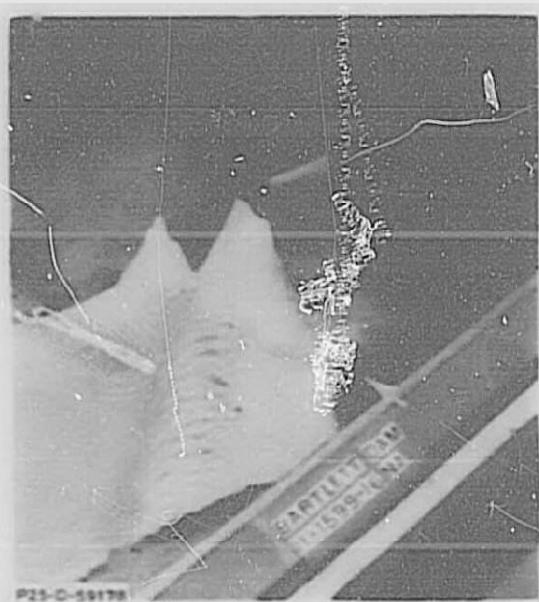
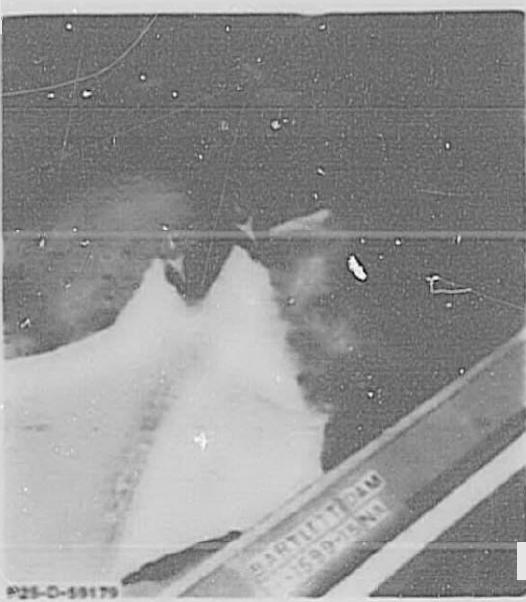
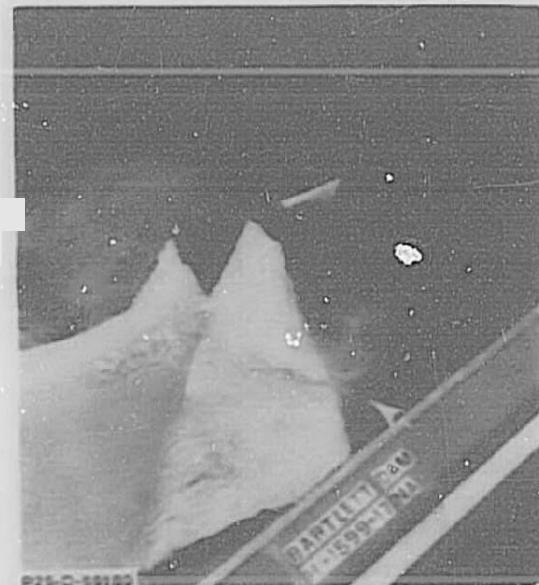
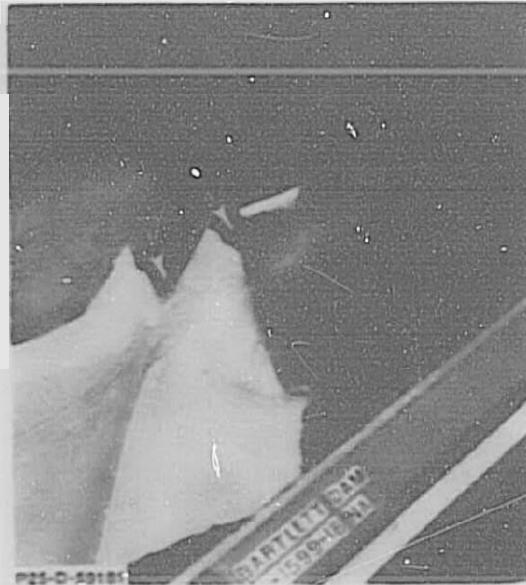
Figure 10
Report No. Hyd-576

Various combinations of operating gates were tested (Figure 10) to determine the combination that would provide optimum flow distribution in the chute. These tests showed that closing the right gate reduced the flow impingement on the right bank along the edge of the paved area and increased the impingement along the left bank. With the left gate closed, the reverse was true. These flow conditions were more pronounced when either the left or right gate was operated singly. The tests showed that all three gates should be opened equally for best flow distribution from the chute.

The areas of flow impingement on the left and right banks beyond the white paved area are indicated by the arrows.

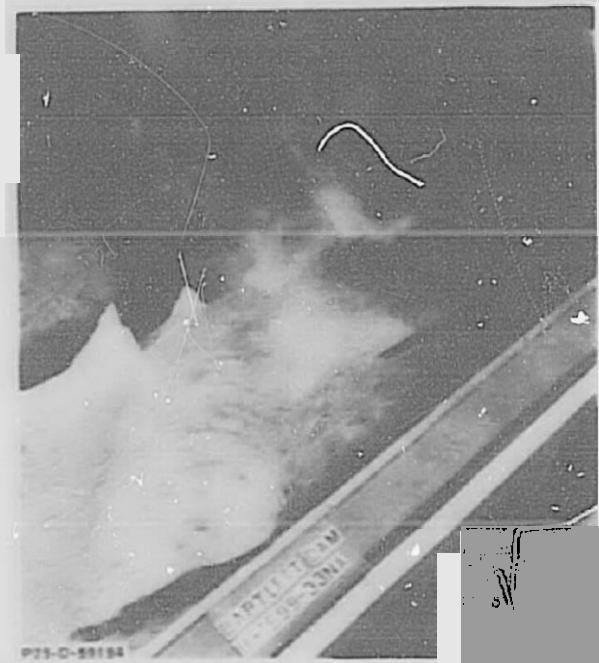
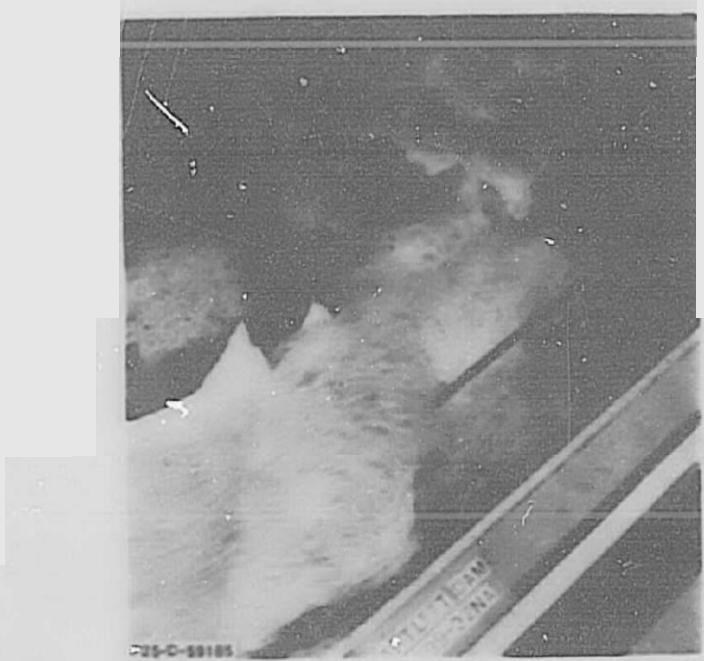
Figure 12
Report No. Hyd-576

4. At flows greater than about 50,000 cfs (1,415 cms) part of the jet will impinge in the downstream portion of the channel beyond the paved area (Figure 12); however, erosion damage will be sufficiently remote that the foundation of the spillway should not be endangered.

At flows of 100,000 (2,830) and 125,000 cfs (4,052.50 cms) (Figure 12) part of the jet impinged near the first ridge in the downstream portion of the discharge channel beyond the paved area. Discharges of these magnitudes will probably cause considerable erosion in the prototype channel remote from the spillway chute.

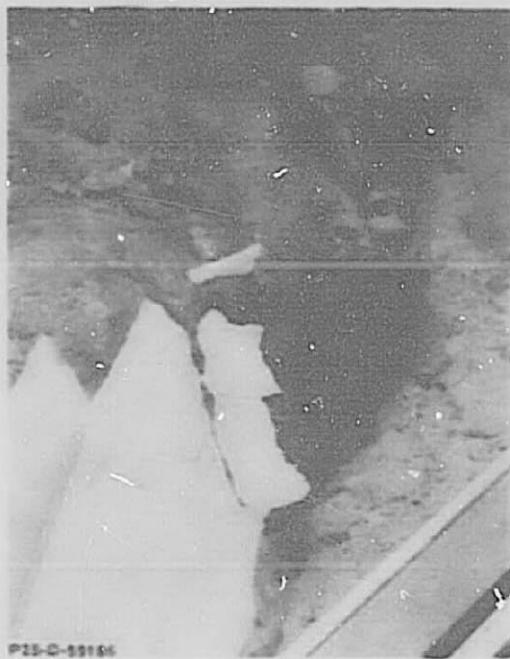
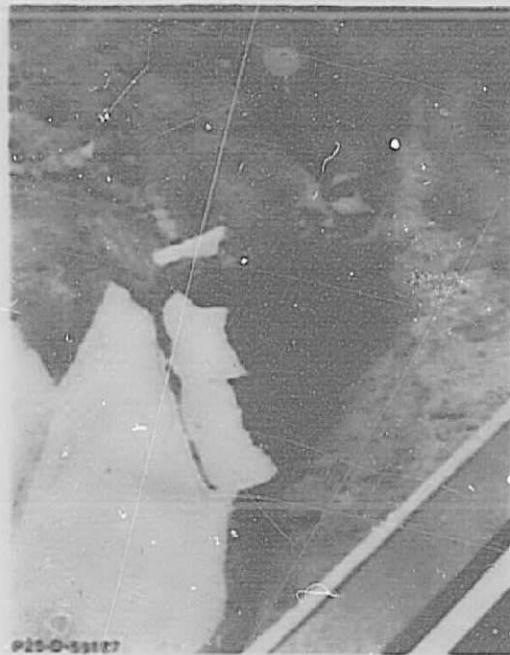
Figure 13
Report No. Hyd-576

The two ridges were constructed in the model so that they could easily be removed and the channel could be tested with and without the ridges in place (Figure 13). Tests were run at discharges of 20,000 cfs (566 cms) and 50,000 cfs (1,415 cms) to determine the effect of removing either or both ridges. The tests showed that any loose rock that might fall into the channel will flush from the area, with or without the ridges in place.

- A. First and second ridges are removed to the elevation shown. Ridge locations are indicated by the arrows.

- B. First ridge only is removed.

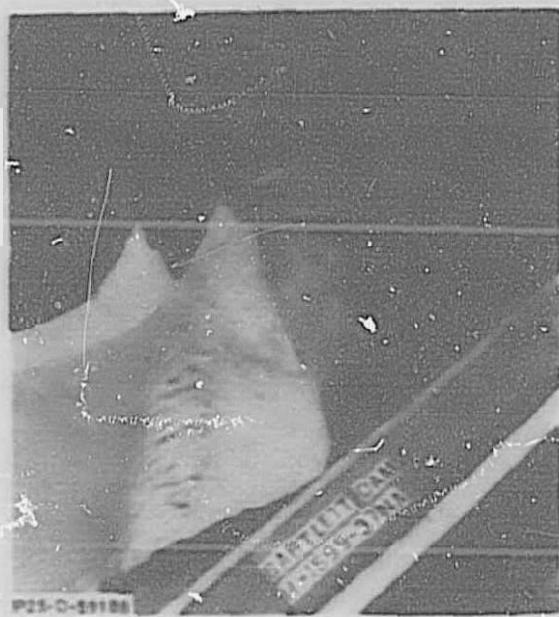
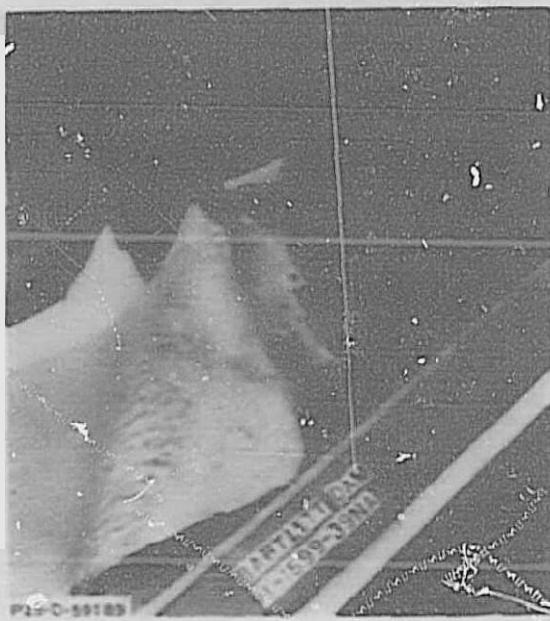
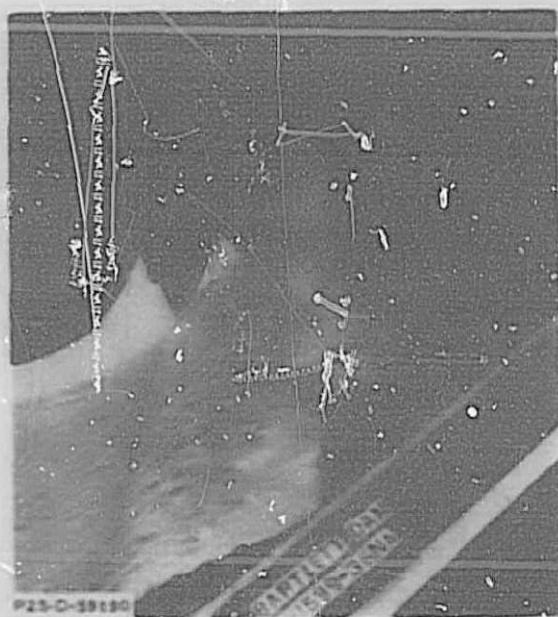
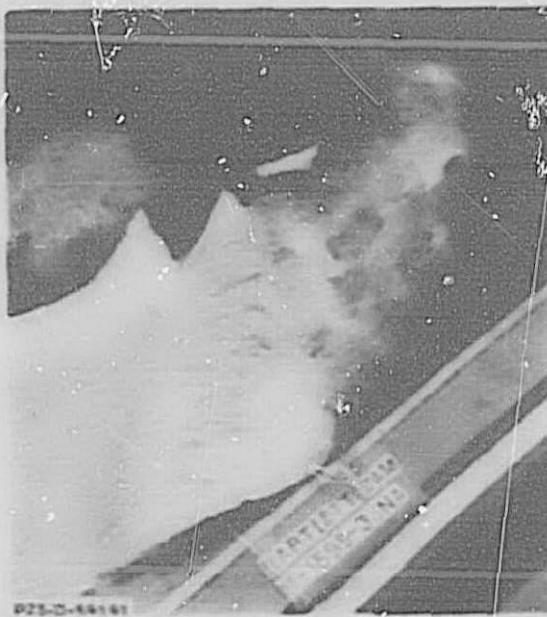
Figure 14
Report No. Hyd-576

7. The upstream ridge and the existing weir in the left branch of the channel help form a shallow pool at the base of the paved slope for flows up to 50,000 cfs (1,415 cms) (Figure 14). This pool aids in absorbing some of the energy in the jet and in reducing erosion.

Actually, the upstream ridge and the existing weir at approximately elevation 1640 in the left branch of the discharge channel (Figure 14) maintain a pool for flows up to 50,000 cfs (1,415 cms). This pool appeared to absorb part of the energy of the falling jet which would reduce the erosion damage (Figure 14); and, therefore should not be removed.

A. Recommended concrete fill

B. Concrete fill with first ridge removed is not recommended
